## GV-QR1352 13.56 MHz Access Card Reading Issue

**Article ID: GV4-26-07-23-T**

**Release Date: Jul. 23, 2026**

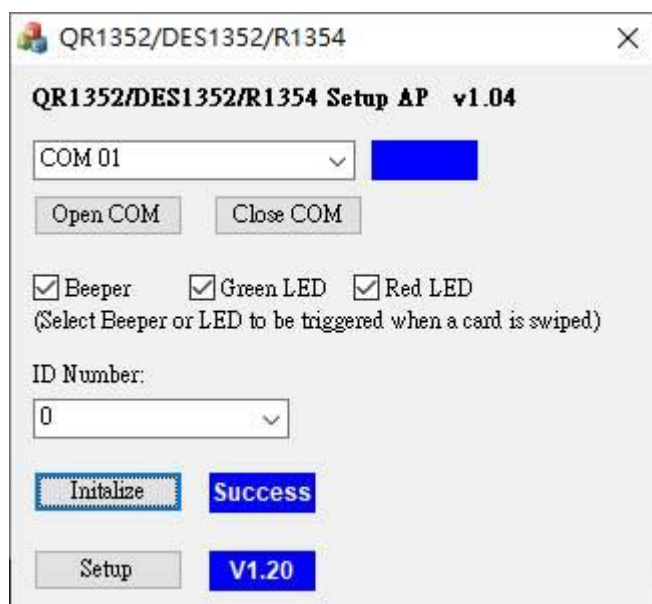
This issue occurs if the GV-QR1352 has previously been configured through Setup AP with Beeper, Green LED, and Red LED enabled simultaneously during card reading.
