# GV-Recording Server Temporary Interruption Due to Software Motion Detection

**Article ID: GV2-25-10-17-T**  
**Release Date: Oct. 17, 2025**

GV-Recording Server V2.1.1

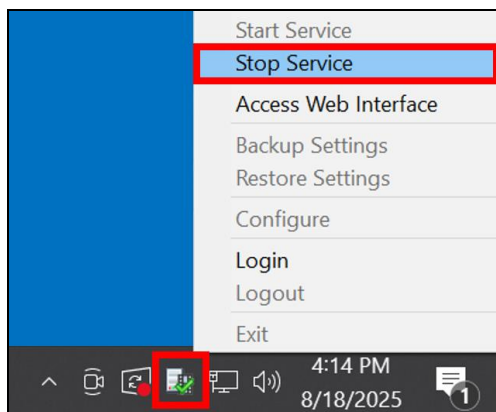
GV-Recording Server may experience instability when software motion detection is enabled, causing a temporary error and brief camera disconnection before recovery within one minute.

1. Right-click the **GV-Recording Server** icon in the taskbar notification area, select **Stop Service**, and then type your ID and password to stop the Server Service Manager.
