GV-TNVR1620-P / TXVL1610 Not Detected in GV-IP Device Utility

Article ID: GV4-26-02-06-T
Release Date: Feb. 6, 2026

- GV-TNVR1620-P
- GV-TXVL1610

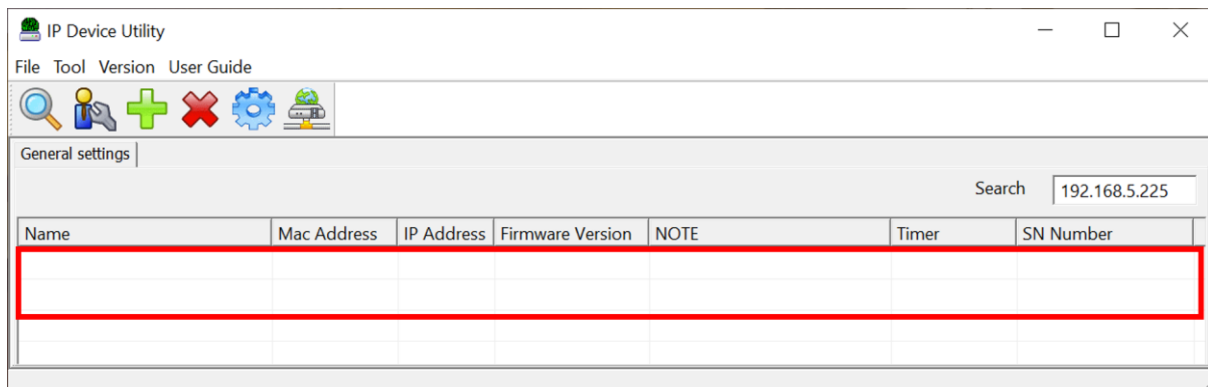
Symptom 1:

When searching for the standalone device by typing its IP address in GV-IP Device Utility, the device may not be detected.

To resolve this issue, contact GeoVision HQ support (support@geovision.com.tw). The issue will be fixed via a remote connection.

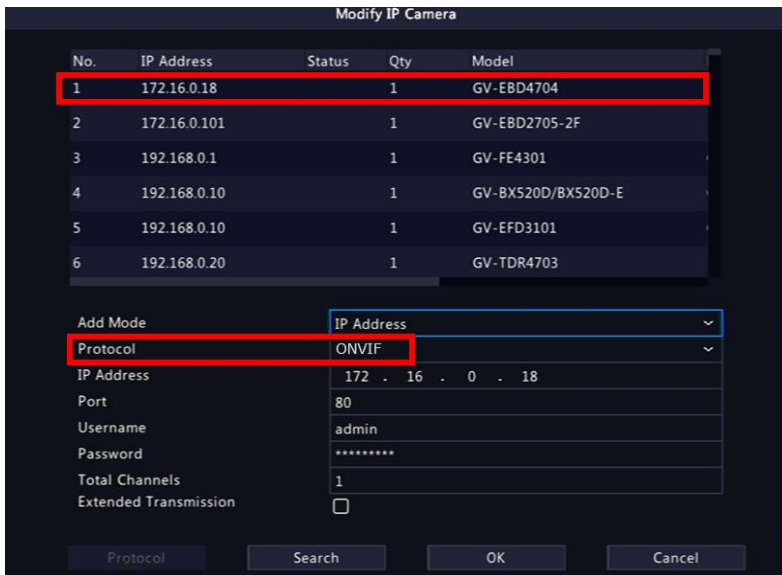
Symptom 2:

When adding a GV-IP Camera on the standalone device, GeoVision is not automatically selected in the Protocol field of the Modify IP Camera window.

In the Modify IP Camera window on the standalone device, manually select **GeoVision** in the Protocol field.
